Greener Shingles Rejuvenator Shingle Rejuvenator Study September 10, 2023 Page 2 of 14

#### **CONCLUSIONS: Primary Property Assessment**

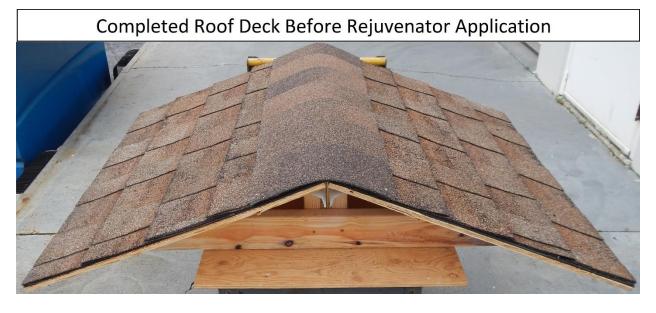
## **APPENDIX A-1 (Roof Deck Construction):**

## **Ridge Cap Installation:**

A type of common, commercially used ridge-cap shingles were then cut and applies to the cap of the roof deck. The cap was selected for the closest visual match to the shingles used.

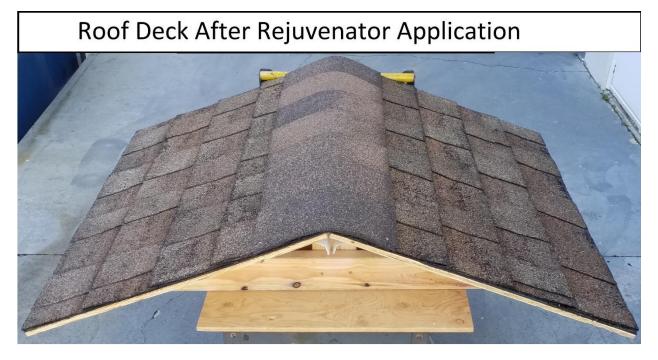
## APPENDIX A-2 (Roof Deck Construction):

### **Application of Rejuvenators:**

The Greener Shingles Rejuvenator was prepared and applied according to manufacturer guidelines using common garden spray bottles and allowed to cure for 24 hours:

- Manufacturer recommendations A mixture of 70% water and 30% Rejuvenator concentrate stirred by hand to homogeneity.
- The product was applied were to one side of the roof deck at a target rate of 1 gallon per 100ft<sup>2</sup> using simple spray bottles.
- The other side was left un-treated.

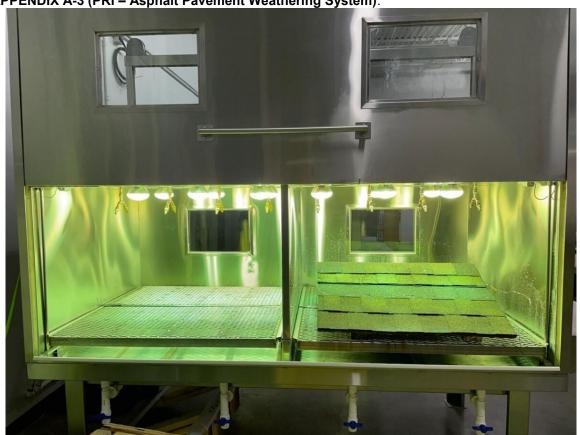
APPENDIX A-3 (PRI - Asphalt Pavement Weathering System):

An open view of PRI's Asphalt Pavement Weathering System with the roof deck positioned in the front chamber (right).

PRI's APWS was used for accelerated weathering of the roof deck after the application and curing of the rejuvenators. The weatherometer is monitored daily for even light distribution and water spray coverage, while temperature of the chamber, roof surface, water, ambient temperature and relative humidity are all tracked continuously.

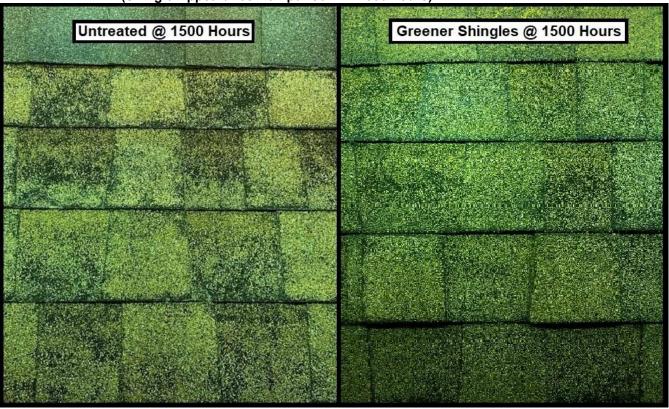
APPENDIX A-4 (Shingle Appearance Comparison - ~1500 hours):

There is a notable difference in appearance between the untreated and treated shingles after 1500 Hours.

- **Shingle Color and Appearance:** After 1,500 and 3,000 hours of exposure, the shingles treated with Greener Shingles Rejuvenator exhibit a significantly different appearance than those left untreated.

- Un-treated shingles show a clear increase in the roofing granules lost. (Appendix A-4/5)

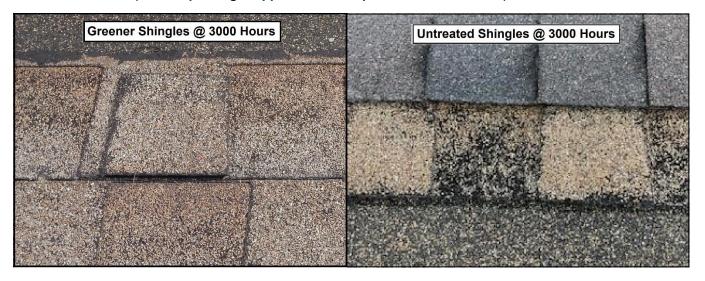
APPENDIX A-6 (Close-Up Shingle Appearance Comparison - ~3000 hours):

There is a notable difference in appearance between the untreated and treated shingles after 3000 Hours.

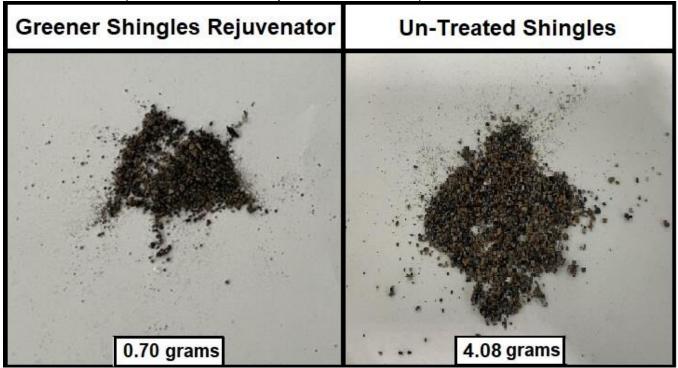
APPENDIX A-7 (Granular Wash off Comparison – ~1500 hours):

Granules and particulate washed from the roof decks after 1500 hours of exposure. Particles have been filtered from the accompanying runoff water and dried for quantification.

- After 1,500 hours of exposure the mass of the collected particulate from the un-treated shingles was 4.08g compared to 0.70g for the Greener Shingles' rejuvenator.

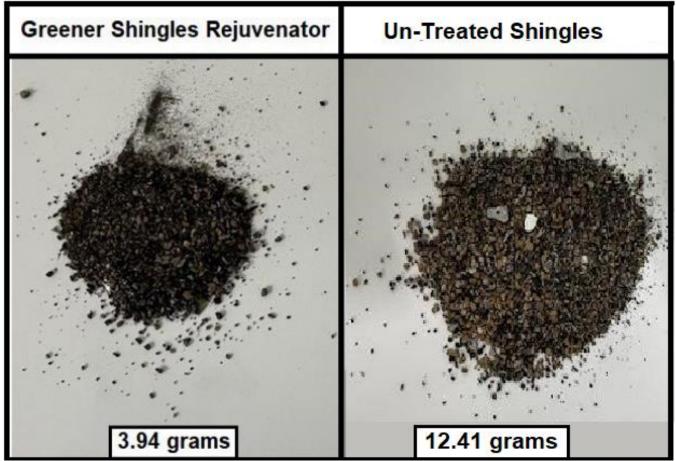
APPENDIX A-8 (Granular Wash off Comparison - ~3000 hours):

Granules and particulate washed from the roof decks after 3000 hours of exposure. Particles have been filtered from the accompanying runoff water and dried for quantification.

- Greener Shingles Rejuvenator performs 5.8 times better than un-treated shingles
  - After 3,000 hours of exposure the mass of the collected particulate from the un-treated shingles was 12.41g compared to 3.94g for the Greener Shingles' rejuvenator.

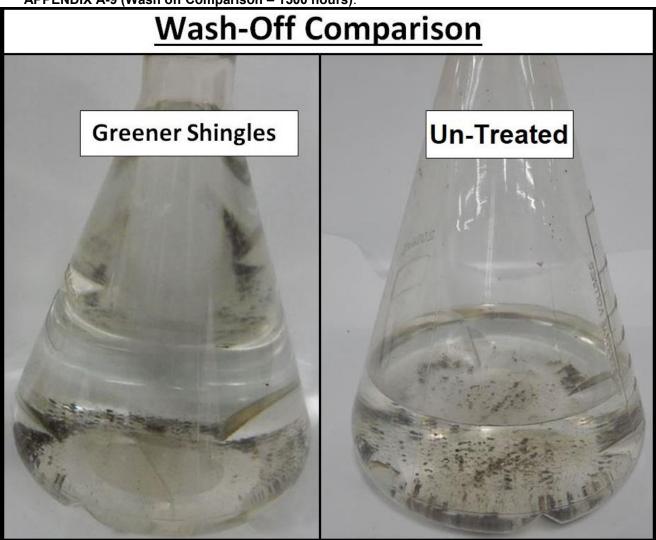
APPENDIX A-9 (Wash off Comparison - 1500 hours):

Granules and particulate washed from the roof decks after 1500 hours of exposure. Particles collected from sediment traps on the weatherometer.

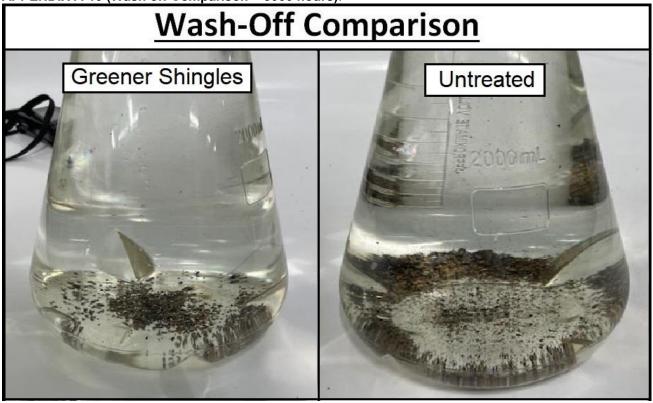
APPENDIX A-10 (Wash off Comparison - 3000 hours):

Granules and particulate washed from the roof decks after 3000 hours of exposure. Particles collected from sediment traps on the weatherometer.
